Summary of the FAA's Review of the Boeing 737 MAX

Return to Service of the Boeing 737 MAX Aircraft

Date: November 18, 2020

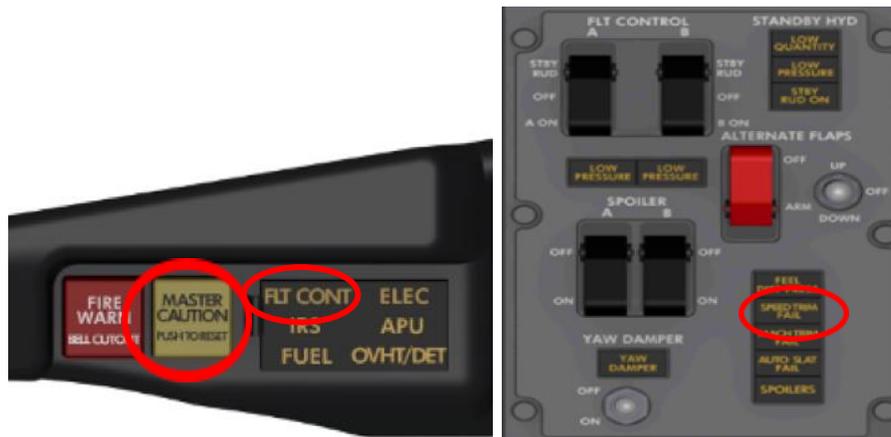
FIGURE 2 SPEED TRIM FAIL ANNUNCIATION

Effect of Erroneous AOA Value on MCAS — if the valid AOA value differs from the other valid AOA sensor value by more than 5.5 degrees for a specified duration the AOA values are considered erroneous, the split vane monitor will detect the failure and both the MCAS and Speed Trim functions will be disabled for the remainder of the flight. Activation of the split vane monitor will completely disable the STS (which includes both MCAS and Speed Trim System), will trigger a Master Caution indication, an illumination of the Flight Control (FLT CONT) annunciator, and an illumination of the SPEED TRIM FAIL light on the

overhead panel. The Master Caution indication and the FLT CONT annunciator can be reset by pressing the MASTER CAUTION PUSH TO RESET button. The SPEED TRIM FAIL light will remain illuminated for the remainder of the flight. In addition, an accompanying maintenance item is recorded for the loss of MCAS and Speed Trim. The SPEED TRIM FAIL annunciation is shown in Figure 2.

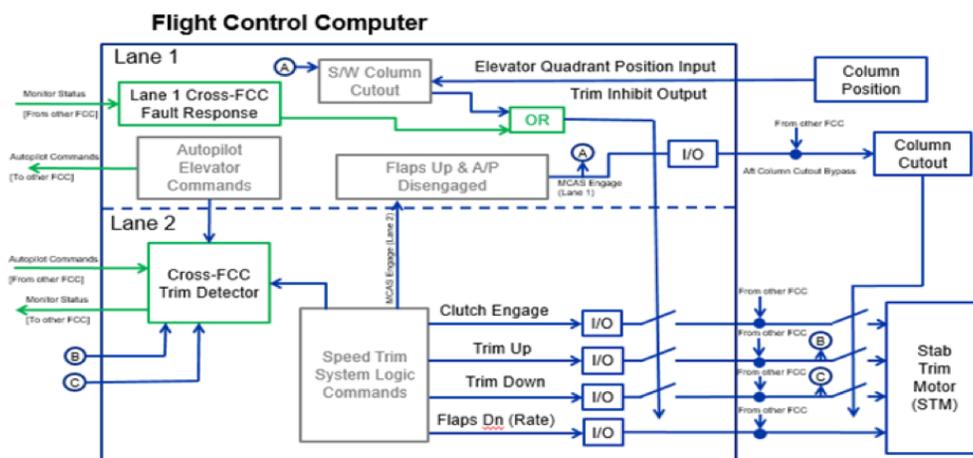
FIGURE 3 SIMPLIFIED SCHEMATIC OF THE UPDATED FCC SOFTWARE

The Cross-FCC Trim Monitor is a new feature to address Safety Item #6: OTHER POSSIBLE FCC STABILIZER RUNAWAY FAILURES and provides additional protection against erroneous FCC trim commands caused by postulated failures in the FCC Lane 2 CPU or I/O chips. This monitor is implemented in Lane 2 of the FCC.

A simplified schematic of the Cross-FCC Trim Monitor added in the updated FCC software is shown in Figure 3 below.

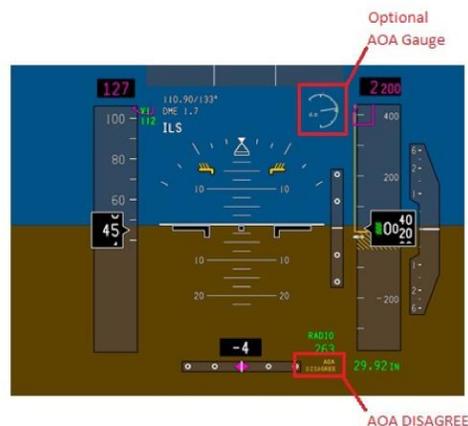
FIGURE 4 737 MAX MDS PFD WITH AOA DISAGREE AND AOA GAUGE

The 737 MAX MDS software change updates the AOA DISAGREE annunciation logic and addresses Safety Item #5: AOA DISAGREE. The AOA DISAGREE annunciation is displayed on the captain's and first officer's PFD when the left and right AOA values differ by more than 10 degrees for longer than 10 continuous seconds. An optional AOA gauge displays the AOA value on the captain's and first officer's PFD when the option is enabled. The AOA DISAGREE annunciation and AOA gauge are illustrated in Figure 4.

- Ensure the AOA DISAGREE annunciation logic is always enabled, regardless of the AOA gauge option.
- Maintains the AOA DISAGREE annunciation below 400 feet radio altitude displayed through landing to avoid the flightcrew missing the alert during a high workload condition.

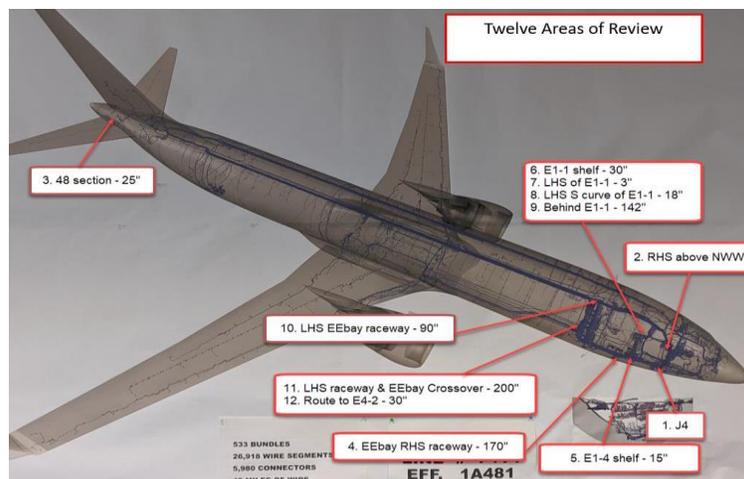
FIGURE 5 737 MAX STABILIZER TRIM MOTOR WIRE SEPARATION

As part of the FAA's review of these design changes, the agency re-reviewed the entirety of the 737 MAX horizontal stabilizer control system. This review revealed that the physical separation of the horizontal stabilizer trim-arm wiring and the horizontal stabilizer trim-control wiring does not meet the criteria specified in 14 CFR 25.1707. The FAA promulgated this design standard in 2007 and therefore it is part of the certification basis of the 737 MAX but not of previous Boeing Model 737 airplanes. Certain wiring installations must have enough physical separation so that a wiring failure cannot create a hazard. (See 14 CFR 25.1707).

Since design changes must comply with FAA regulations, the FAA requires changes to the wiring installation to meet the required physical separation between the horizontal stabilizer trim-arm wiring and the horizontal stabilizer trim-control wiring. This action brings the airplanes into regulatory compliance. The stabilizer trim-arm wiring has since been rerouted in 12 areas of the airplane's Electrical Equipment bay and Section 48 to prevent a potential simultaneous short circuit between the stabilizer arm and control wiring and another 28VDC wire. The 737 MAX design change will include physical separation of existing wires and/or routing of new wires to ensure compliance with the regulation. (See Figure 5).
